REPORT OF INVESTIGATION  
(Underground Coal Mine)

NONINJURY COAL MINE OUTBURST ACCIDENT

Dutch Creek No. 1 Mine (ID No. 05-00301)  
Mid-Continent Resources, Inc.  
Redstone, Pitkin County, Colorado

January 13, 1983

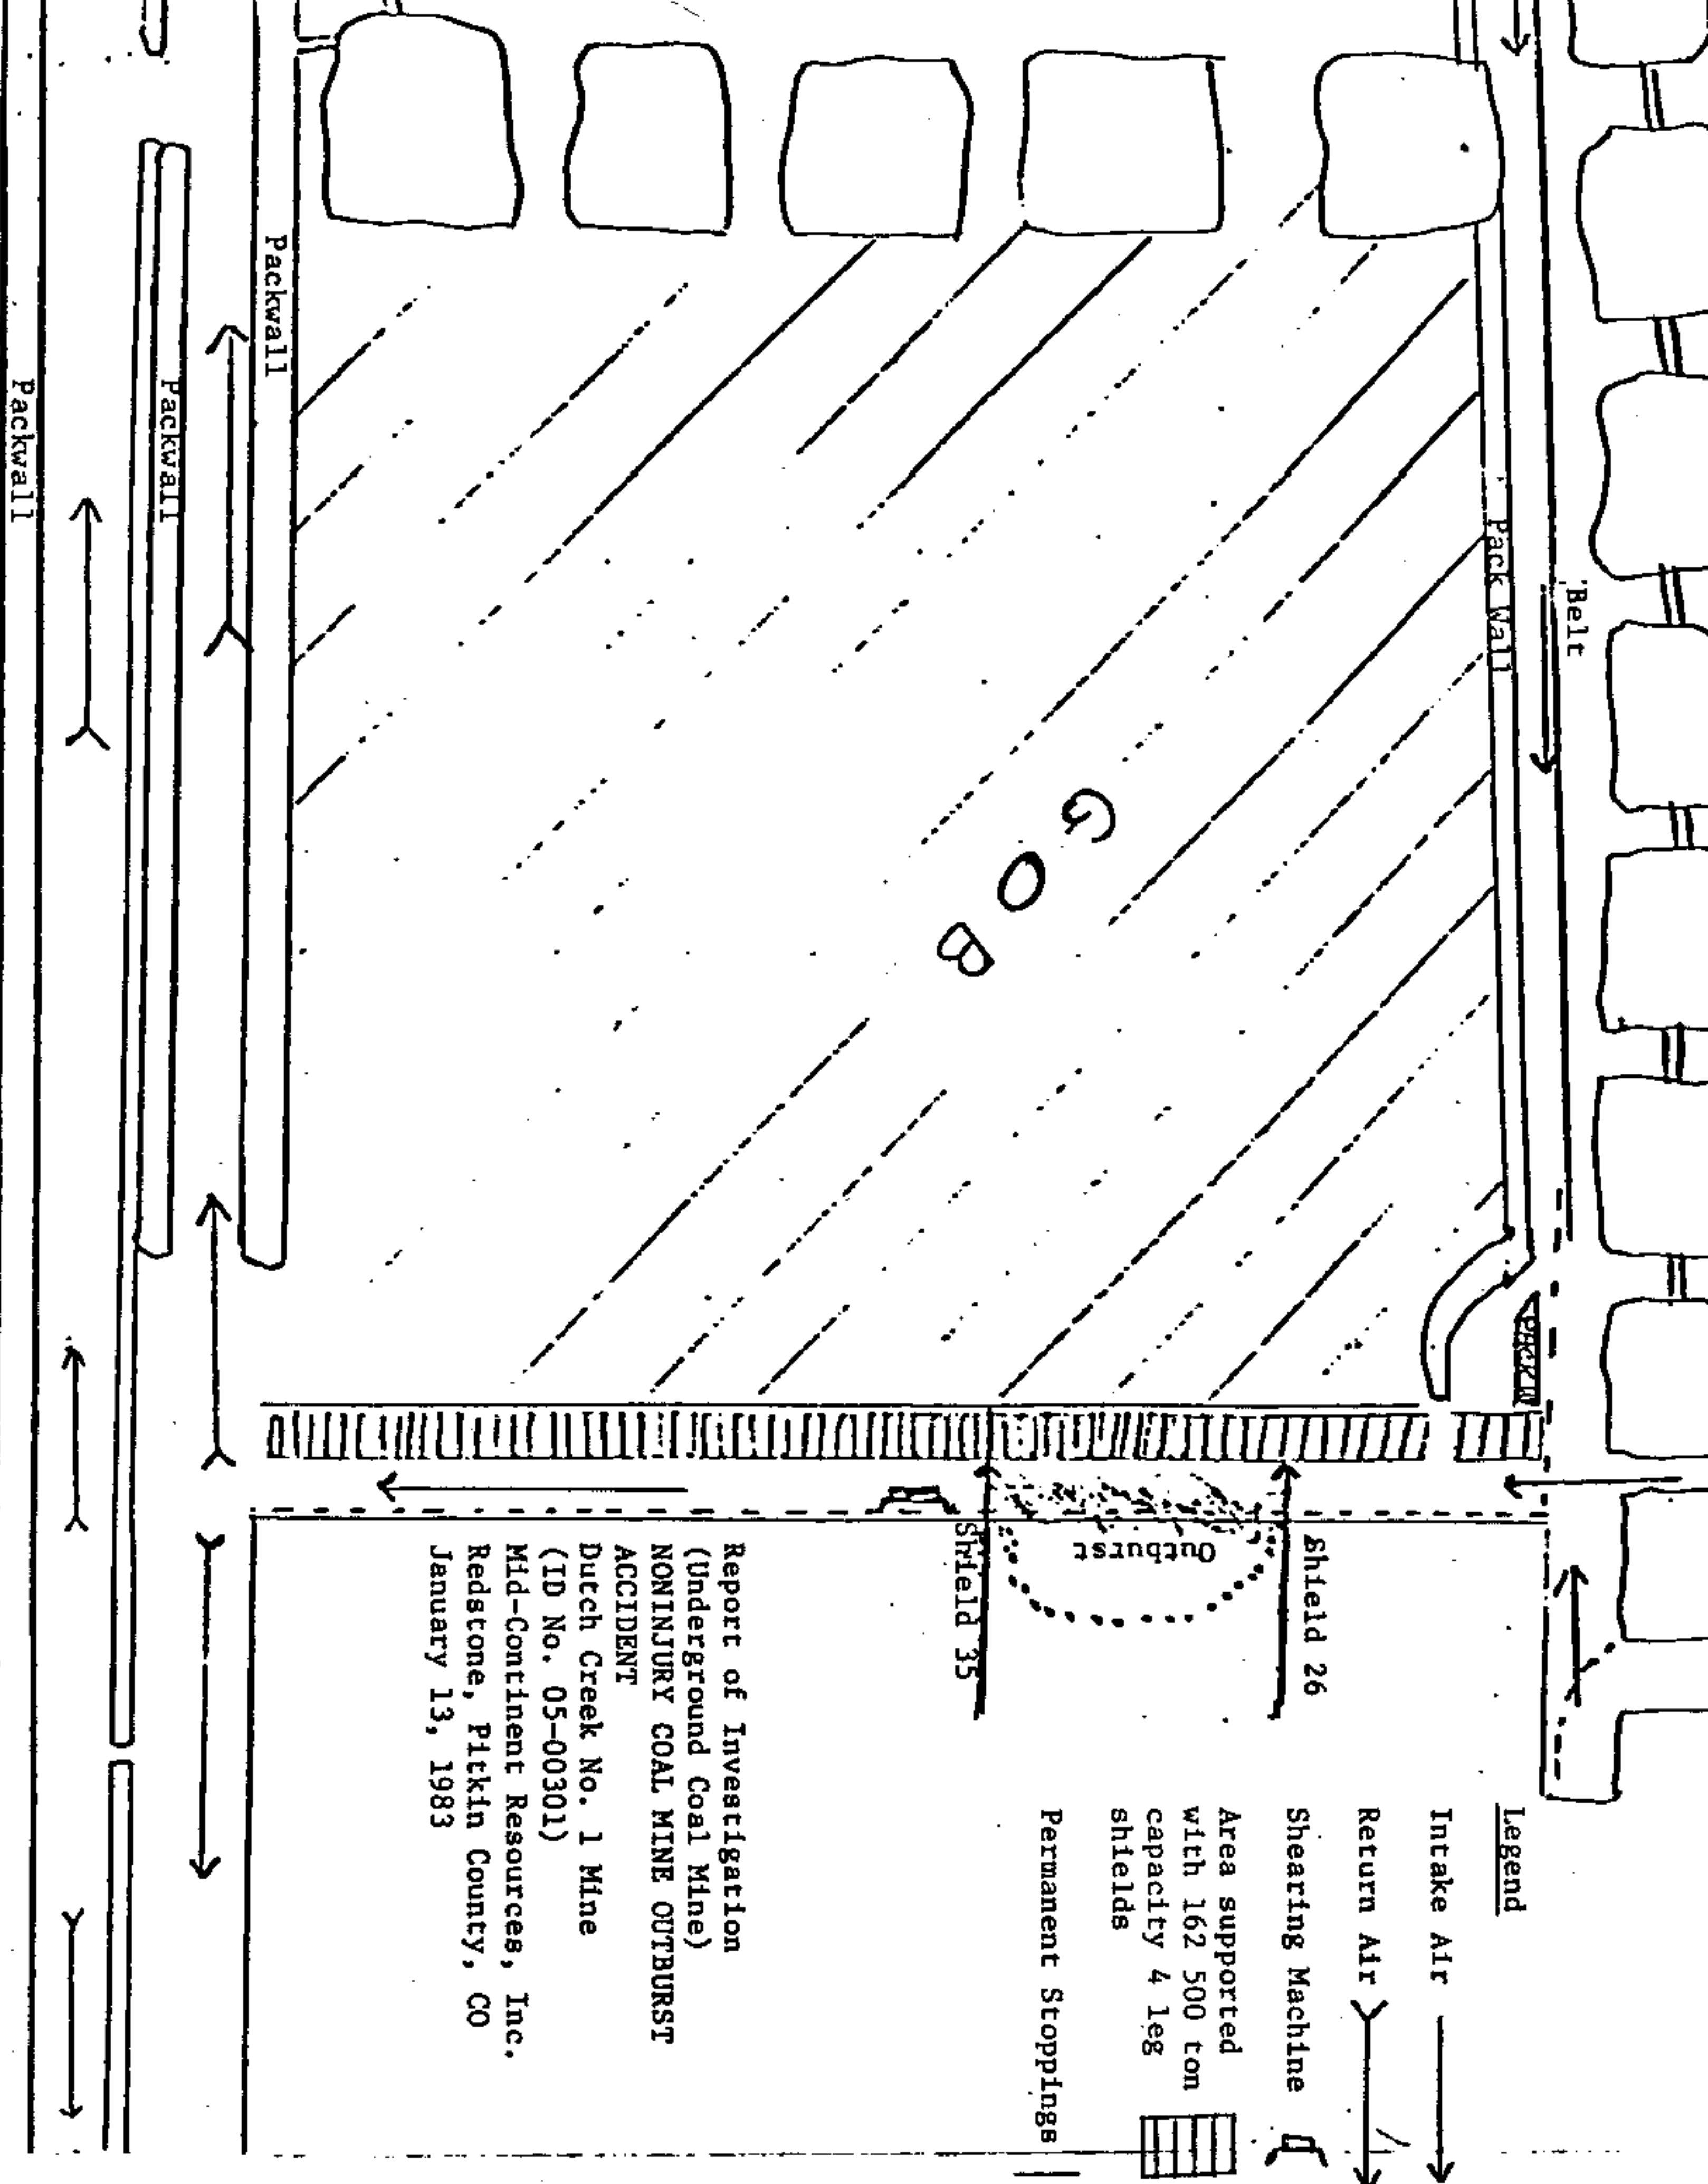
Shield 26

Shield 35

Outburst

1. The force of the outburst coming from the face of the advancing longwall face pushed loose coal approximately 80 inches filling the longwall face conveyor 42 feet between shields 26 to 35.
2. The outburst of coal did affect ventilation.
3. This seam of coal has considerable overburden in excess of 2,500 feet.
4. The longwall face being mined was approximately 800 feet long, being mined by advance longwall method and the construction of packwalls to obtain ventilation and haulage entries.

Probable cause of the outburst of coal was a build-up of pressures on the longwall face due to overburden which is in excess of 2,500 feet.
